BUREAU OF SHIPS GROUP TECHNICAL INSPECTION REPORT

USS GASCONADE (APA85)

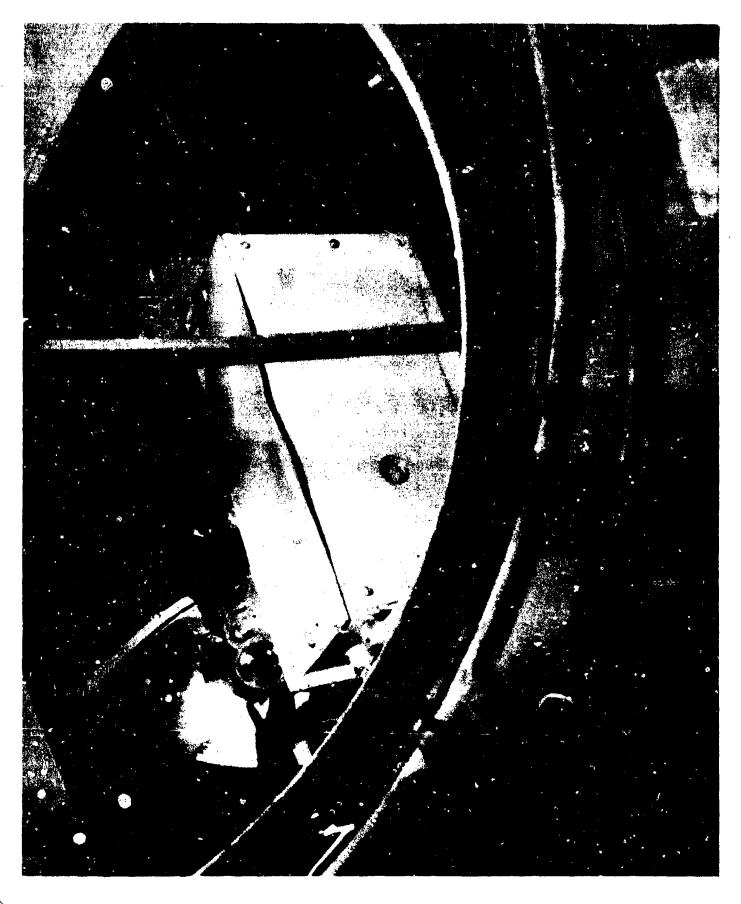
AB-CR-66-143-7. Looking through the front door of the port 24" searchlight. Showing internal disarrangement.
